Elkhorn Slough Watershed

Permit Coordination Program

2004 Implementation Report

Photo Documentation for 2004: Spotlight on Maintenance of Existing Projects

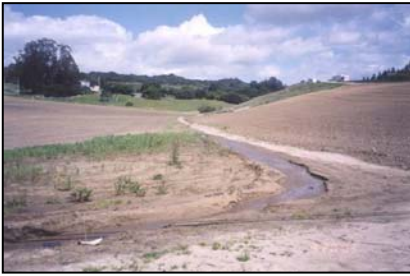
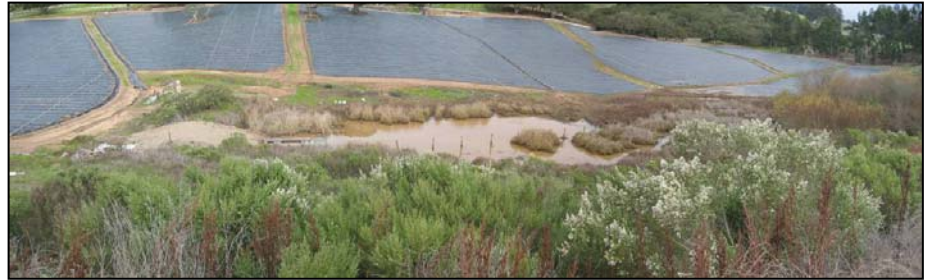
00-002 Before: Water runs down farm road and into nearby channel leading to a busy public road. An old earthen dam and pond had filled in with sediment and needed replacement. **After:** New Water and Sediment Control Basin with outlet pipe at the lower end controls flow of storm runoff and allows water to form a wildlife area above the lower farm road and field. The site was planted with grasses and native plants to stabilize the berm of the basin and hillside.

00-002 Implemented in 2002	Capture sediment, prevent erosion of agricultural fields and control water run off	Water and Sediment Control Basin (638)	60 ft long by 15 ft wide, 120 yds ³	Meter runoff to control flows and prevent sedimentation and erosion.	Storm damaged basin repaired in 2004. Performing as planned.

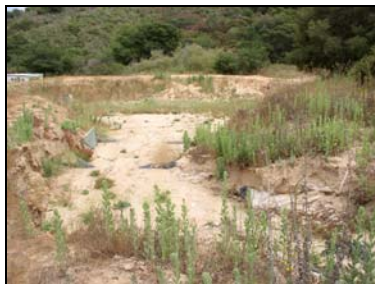
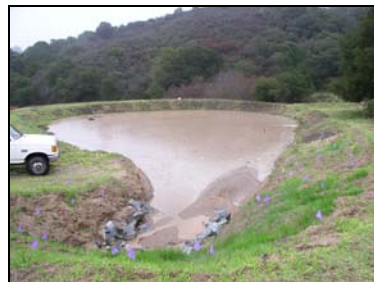
01-004 Before Water and Sediment Control Basin originally constructed in 2001 was not to NRCS standards. **After** Basin repaired and retaining storm runoff after winter rain in December 2004. Berm and banks were planted with grasses and native herbaceous plants.

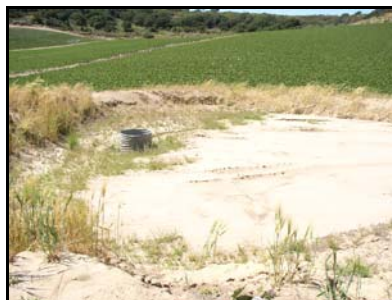
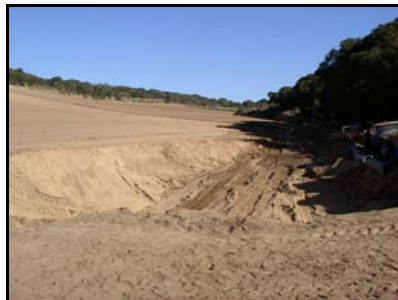
02-002 Before: Water and Sediment Control Basin constructed in 2003 full of sand from winter storms is doing its job. **After:** Sand removed from the basin was returned to the upland farm fields [in spring 2004](#).

01-009 Issue new number in 2002 and revise plan, see 02-002		None Redesigned in 2002. Carried over to 2004.		None	Please refer to 02-002 project status.

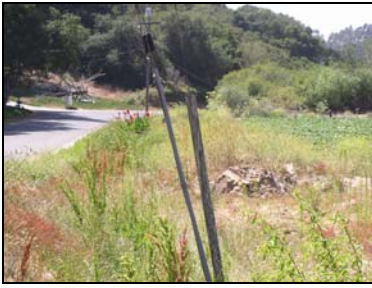
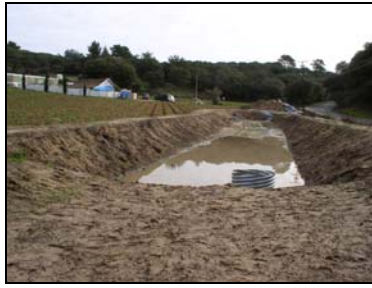
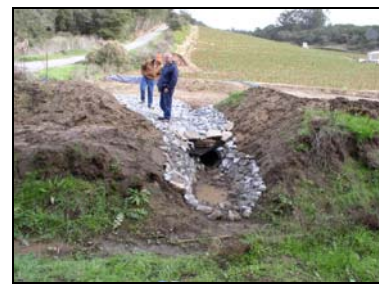
02-004 Before: Roadside drainage and lower field filled with sediment from storm runoff. **After:** Water and Sediment Basin with straw and grass seed placed on berm constructed in 2003 meters water to roadside ditch and culvert preventing sediment from entering road. The third picture is the rock energy dissipater and overflow for the outlet of the basin into the road.

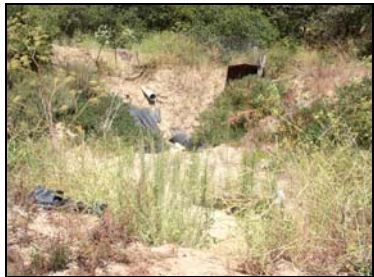
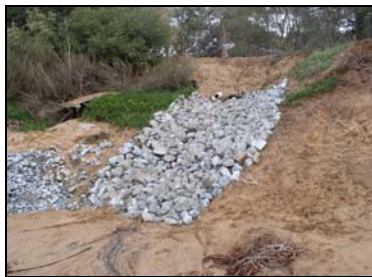
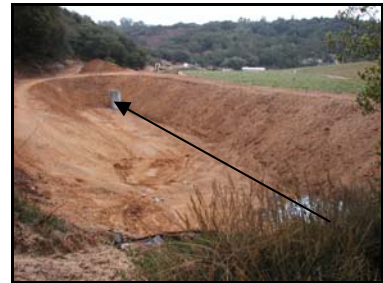
03-002 Before: Makeshift sediment basin installed by farmer. **After:** New Water and Sediment Control Basin with rock energy dissipater showing the inlet pipe constructed in the upper part of the farm in the fall of 2003. The new basin continues to slow down and capture storm water runoff and sediment from the watershed above the farm.

Project No.	Project Purpose	Practices Installed	Conservation Practice Dimensions	Natural Enhancements & Physical Improvements	Project Status
03-002	Improve retention of sediment and control water runoff from farm.	Water and Sediment Control Basin (638) Upper Critical Area Planting (342)	215' L x 50' W .12 acres around basin	Project is within a strawberry farm. The cropland is in an upland sloped area with oak woodland adjacent to the property.	Performing as planned
03-003	Improve retention of sediment and control water runoff from farm.	WSCB (638) by road Critical Area Planting (342)	210' L x 29' W .11 acres around basin	Project is surrounded by a strawberry farm. The cropland is adjacent to Highway 1. Sediment and runoff enter culvert under the highway.	Performing as planned
03-004	Site was highly disturbed former cropland and garbage dump now colonized by willows.	<u>Proposed:</u> Two Sediment Basins (350)	n/a	Site is breeding bird habitat which will be restored to pre-cropland conditions.	Not implemented as of 2004

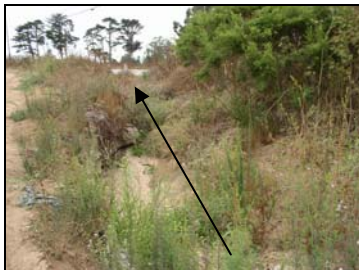
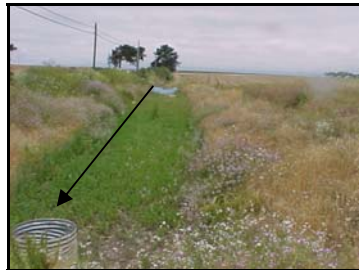
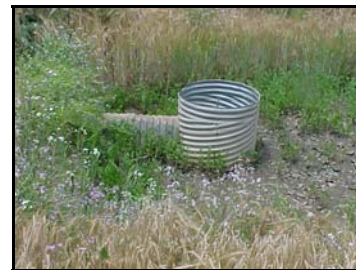
03-003 Before: Sediment from the field and farm roads accumulates next to Highway 1 and continues to flow under the highway through a culvert. **After:** A Water and Sediment Control Basin continues to slow water runoff and captures sediment before water is released to the culvert under the highway. The third picture shows the outlet riser pipe which meters storm runoff from the basin and the adjacent field.

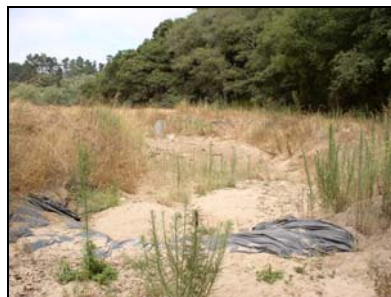
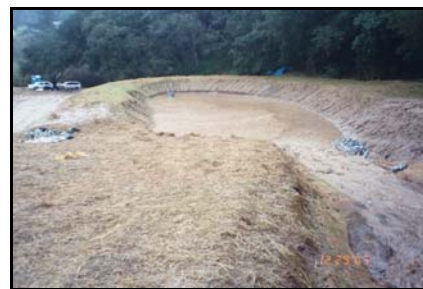
03-005 Before: The first picture shows an existing, poorly constructed Water and Sediment Control Basin. **After:** Repaired Water and Sediment Control Basin captures and meters runoff during a winter storm. The basin is part of a complete system which protects the farm roads and edges from accelerated erosion.

03-005	The site is within a strawberry farm and on the edge of an oak woodland. There is a willow covered riparian area, which is now a drainage ditch next to San Miguel Cyn. Rd within 50 feet, but it is not in the project area.	WSCB (638) Middle	480 cu yds capacity	Nesting bird habitat nearby. No trees will be removed as part of the project. Maybe potential red legged frog habit in the drainage ditch next to San Miguel Canyon Rd. Will conduct pre-construction biological survey.	Performing as planned
